Trentham Rifle Ranges

Heritage Management Plan

June 2011

New Zealand Defence Force

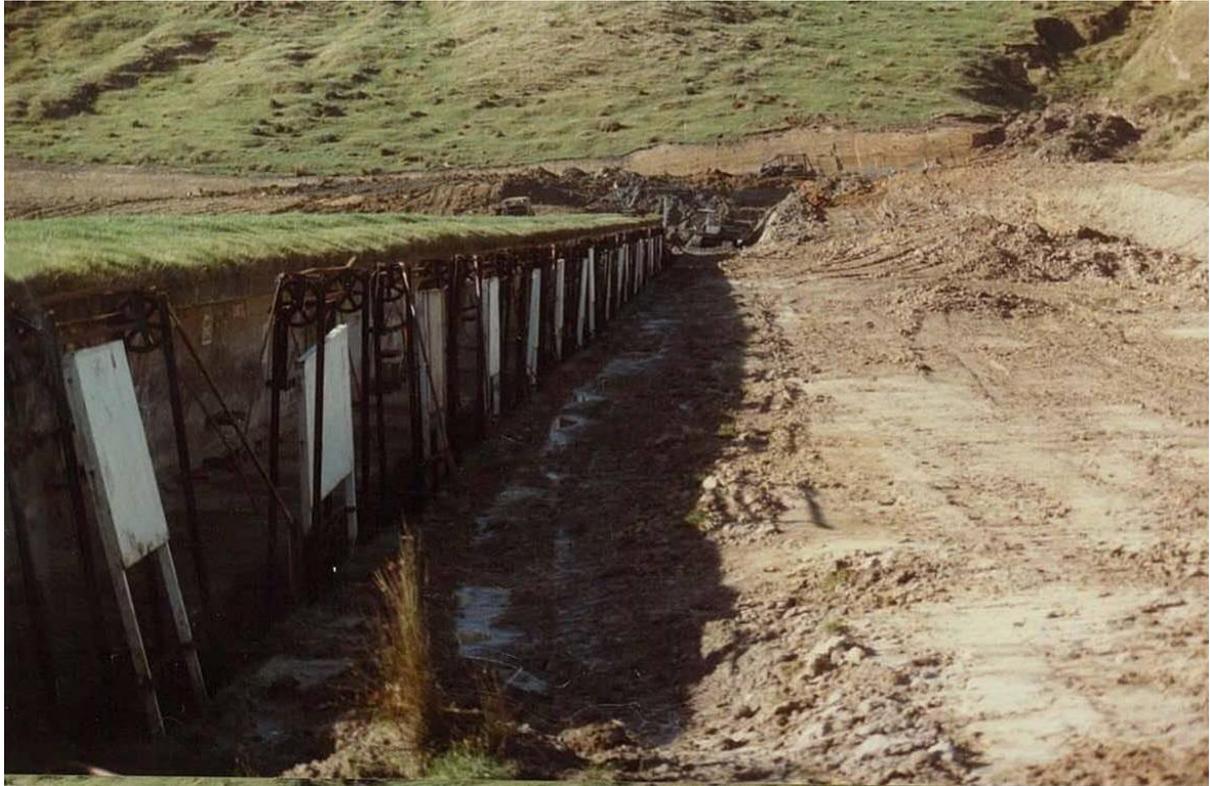
Seddon Range, 1984. The old Hythe pattern frames await removal as the area is prepared for new target hoists. Note the hillside partially removed to accommodate the extended range. (NRANZ)

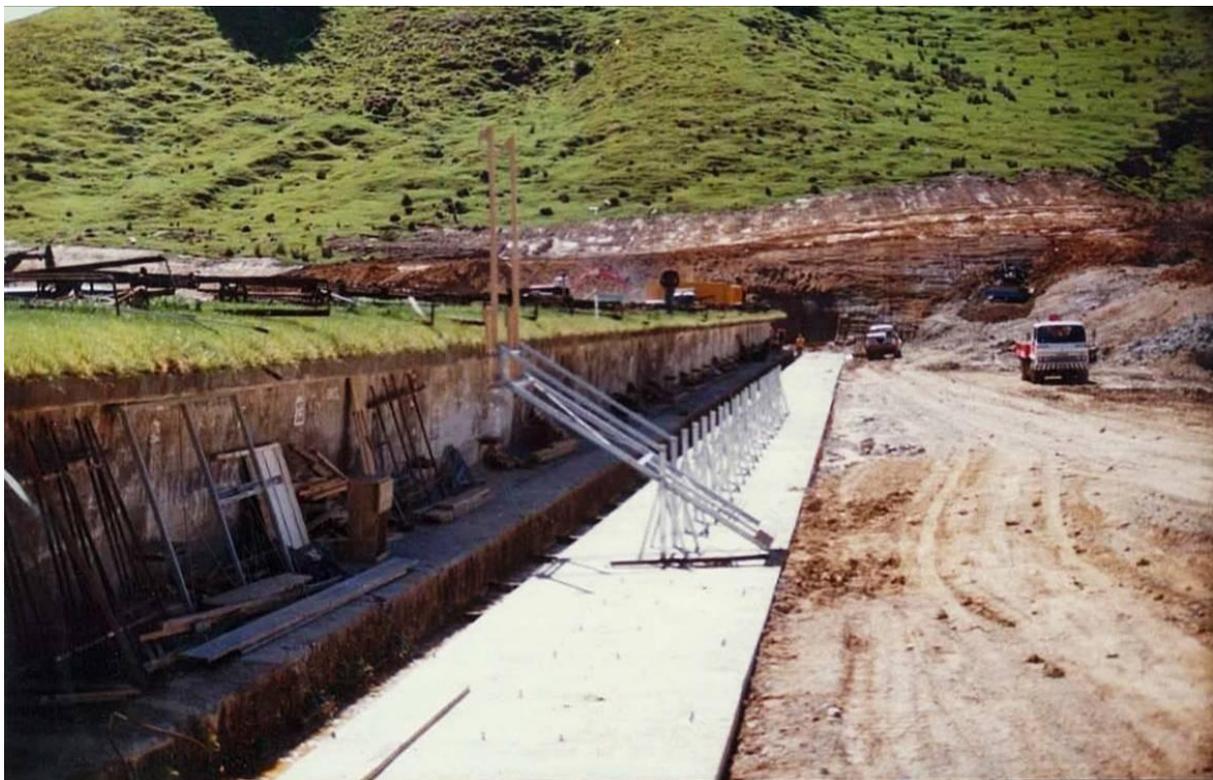
The new target hoists being erected on a new concrete platform. (NRANZ)

The gallery was roughly doubled in size and the Hythe pattern targets replaced with new cantilever frames. These sat on a new enlarged platform. The cost of the infrastructure was \$41,120 with an additional cost of \$40,000 for the new target hoists (\$800 each), which was borne by the NRA.

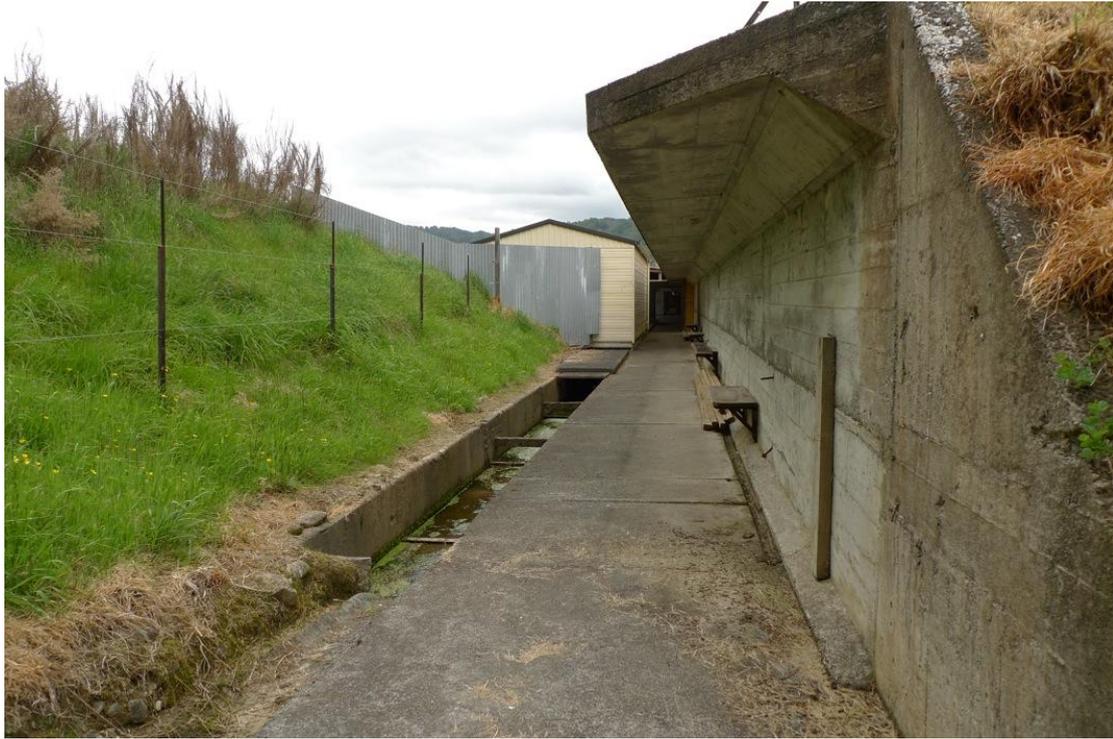
Collins Range, east end of gallery, looking west.

Part of this conversion has included the construction of new light timber structures behind the gallery to provide sheltered firing positions – over about half of the length of the gallery – and the installation of precast concrete covers over the open drain. Over time around half of the old military graffiti on the gallery walls has been painted over – attributed by the HPC to the Army applying green paint to sections of the wall prior to their taking over the range. This was subsequently painted white by the HPC. The surviving graffiti, almost wholly in pencil, is the most extensive and varied of the three ranges and suggests the great deal of historically interesting material that has likely been lost. It includes marks from a wide range of military and other forces and personnel, with dates going back to the early 1940s.

The original (or early) target shed is a distinctive small building situated beside the mantlet at the east end of the gallery. This is a plain gabled timber-framed box, roughly 6 m x 4 m in plan and clad and roofed in corrugated iron, with a nicely made braced and ledged door. It bears instructive marks from receiving many stray rounds over the years, and illustrates why later sheds were more sensibly constructed within the shelter of the mantlets.

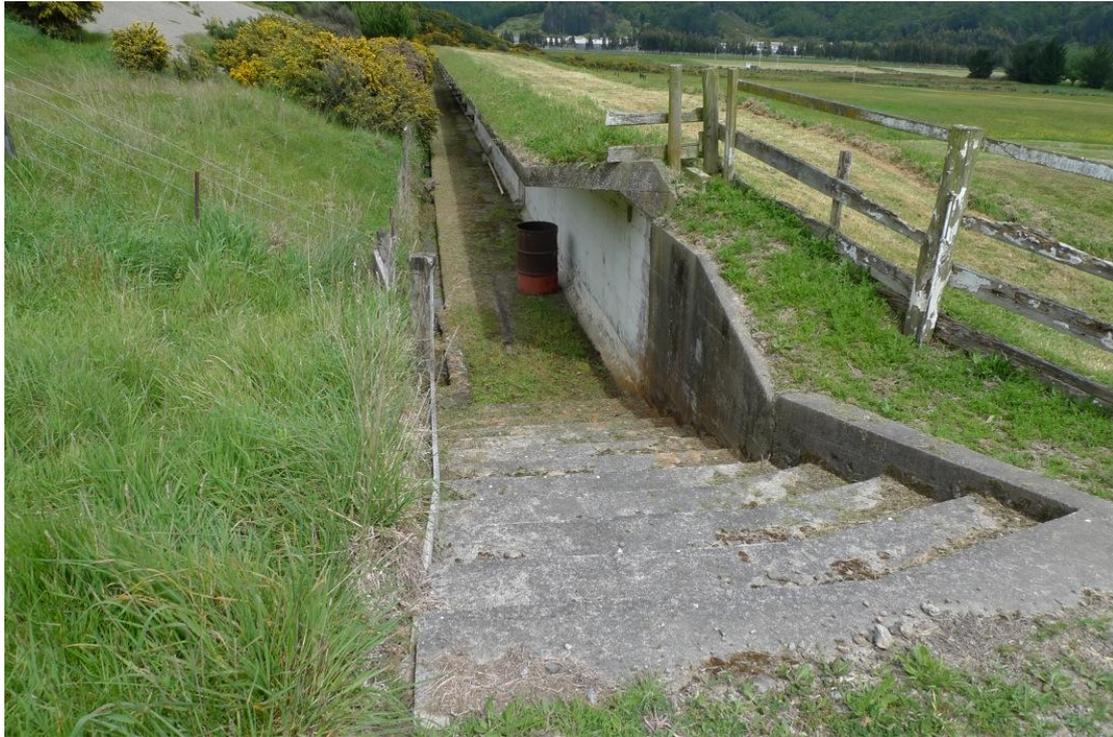
Sommerville Range, east end of gallery, looking west.

Somerville Range has a trapezoidal site, largely due to the encroachment of the golf course over the original range floor, which was some 600 m long. As it stands today, the range is approximately 450 m long to the point of the trapezium and around 120 m wide. There is a 300-yard firing position.

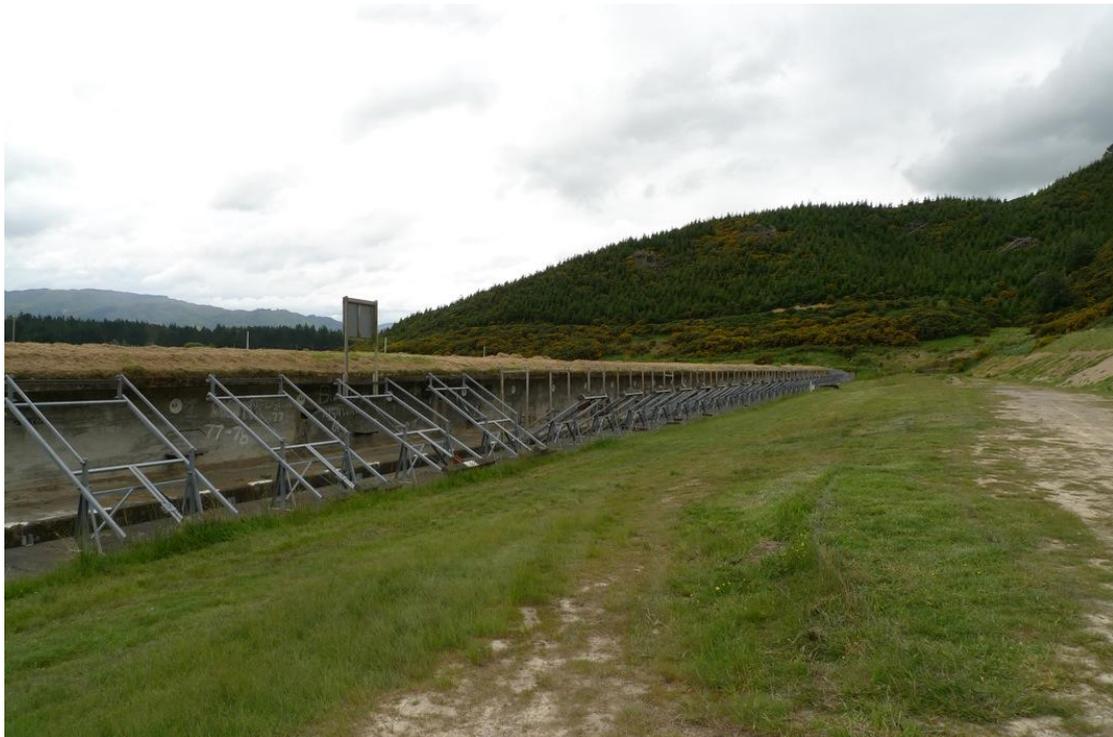
Seddon Range, west end of gallery, looking east.

Seddon Range may be considered the least modified range in the complex, and it is by far the longest, with a 1,000 yard firing mound at the northern end near the main 'Heretaunga Drain'. The range has more or less maintained its original size, although it was effectively widened with the addition of 9 shooting lanes at the east side in 1984. Overall, the range is over 900 m long and nearly 200 m wide, with broad safety strips separating it from Rimutaka Prison at the west and Sommerville Range at the east.

The gallery has a considerable amount of military graffiti, nearly all in pencil; the majority of dates centre around the World War II period and the following years of CMT.⁴⁸ There is also a fair amount of contemporary graffiti, both military and civilian, largely to be found towards the eastern end of the gallery.

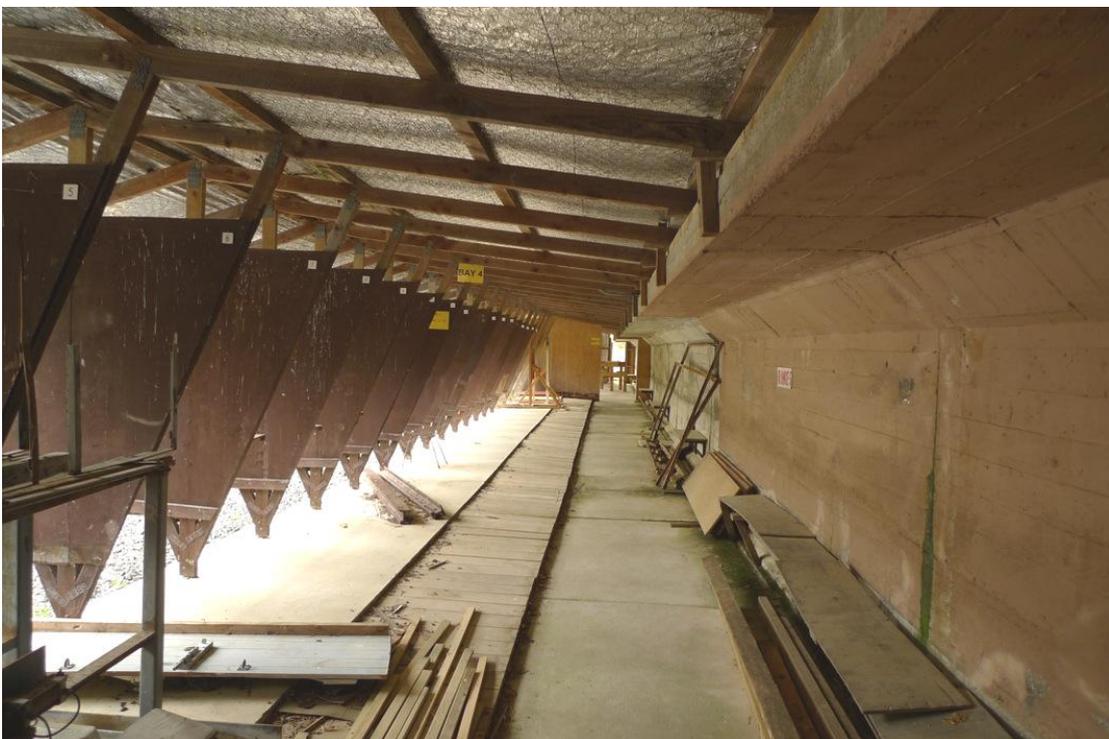
Mid-point of gallery, looking to the west – note partly painted concrete walls and modern timber gallery structures.

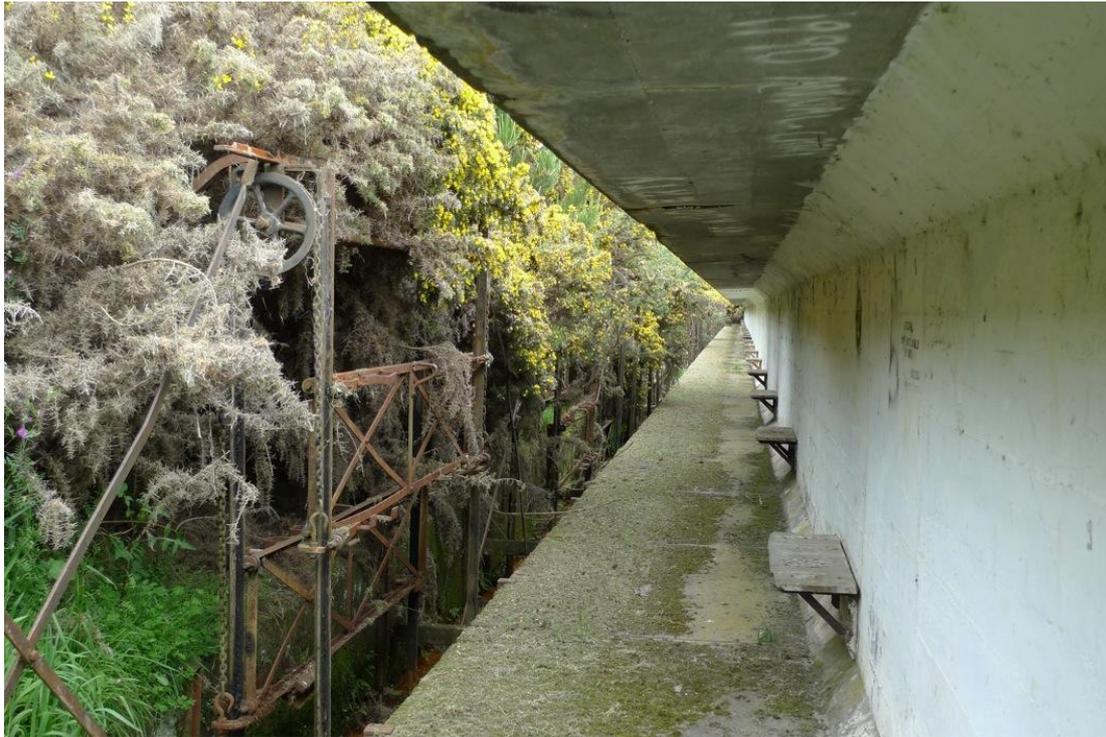
Eastern end of gallery, looking to the west – note, original markers' seats, partly painted concrete walls, old target frames and encroaching vegetation.

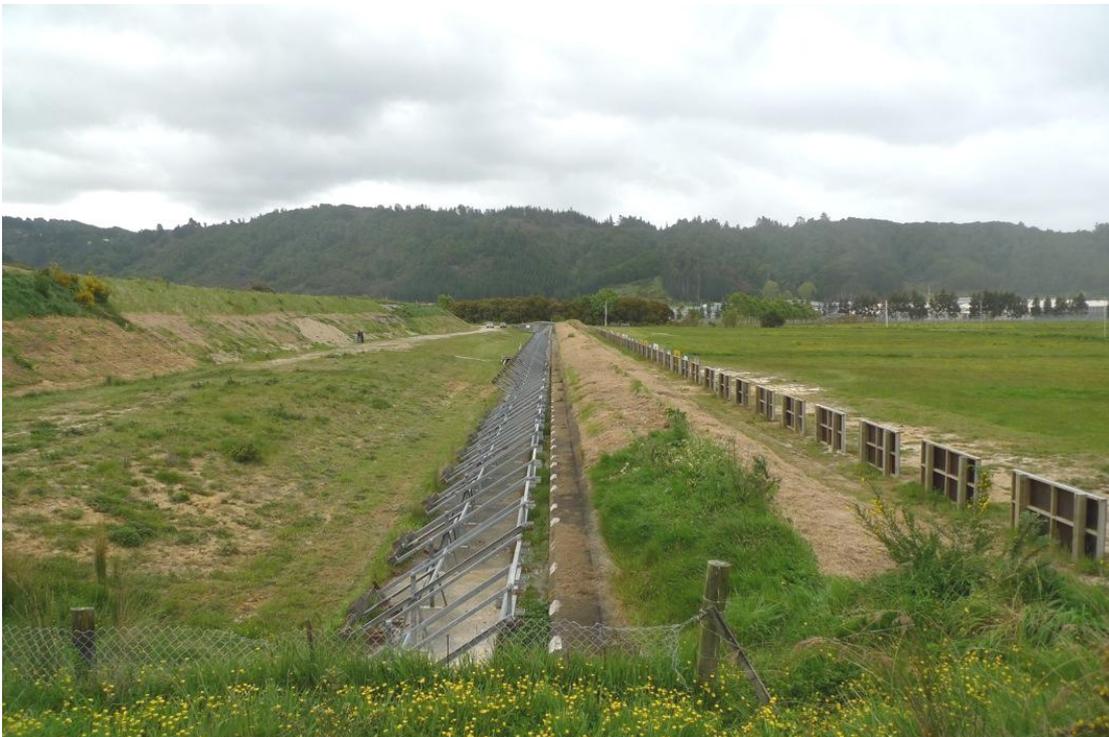
View from east end of range looking west along mantlet. Note lane markers, gallery, target frames and bullet stop.

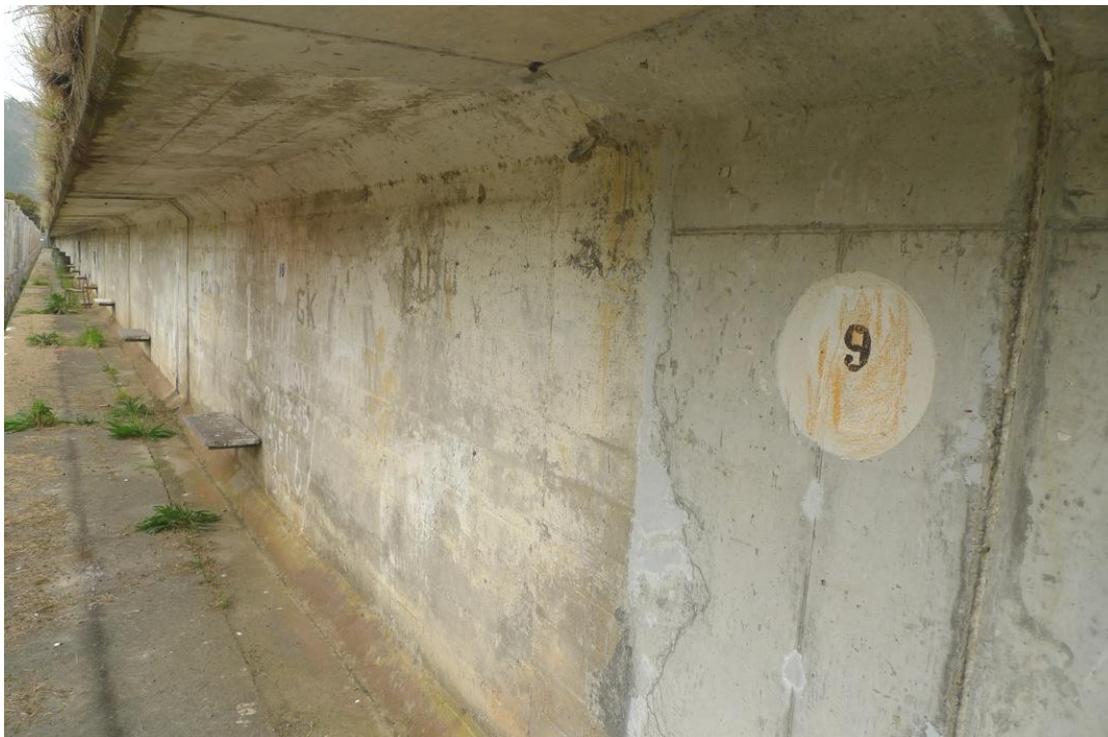
Junction between modern precast gallery and old in situ concrete at lane 9.

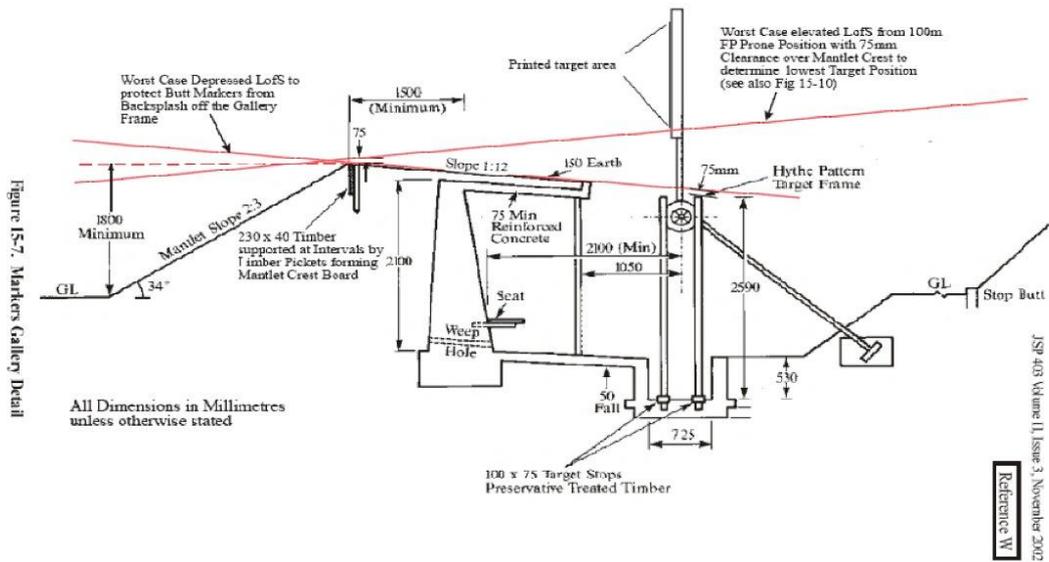
Figure 1 – typical cross section through gallery showing critical geometry (from JSP403, image supplied by NZDF)

The bullet stop is typically a large earthen bank behind the gallery, commonly faced with sand drawn to a specific slope angle to minimise the risk of ricochets and other hazards. The hills behind the ranges served as the original bullet stop feature for the complex; over time, more appropriate bullet stops have been built up at Sommerville and Seddon Ranges to improve safety both for the ranges and the adjoining areas. These bullet stops are significant civil engineering structures in their own right, although more

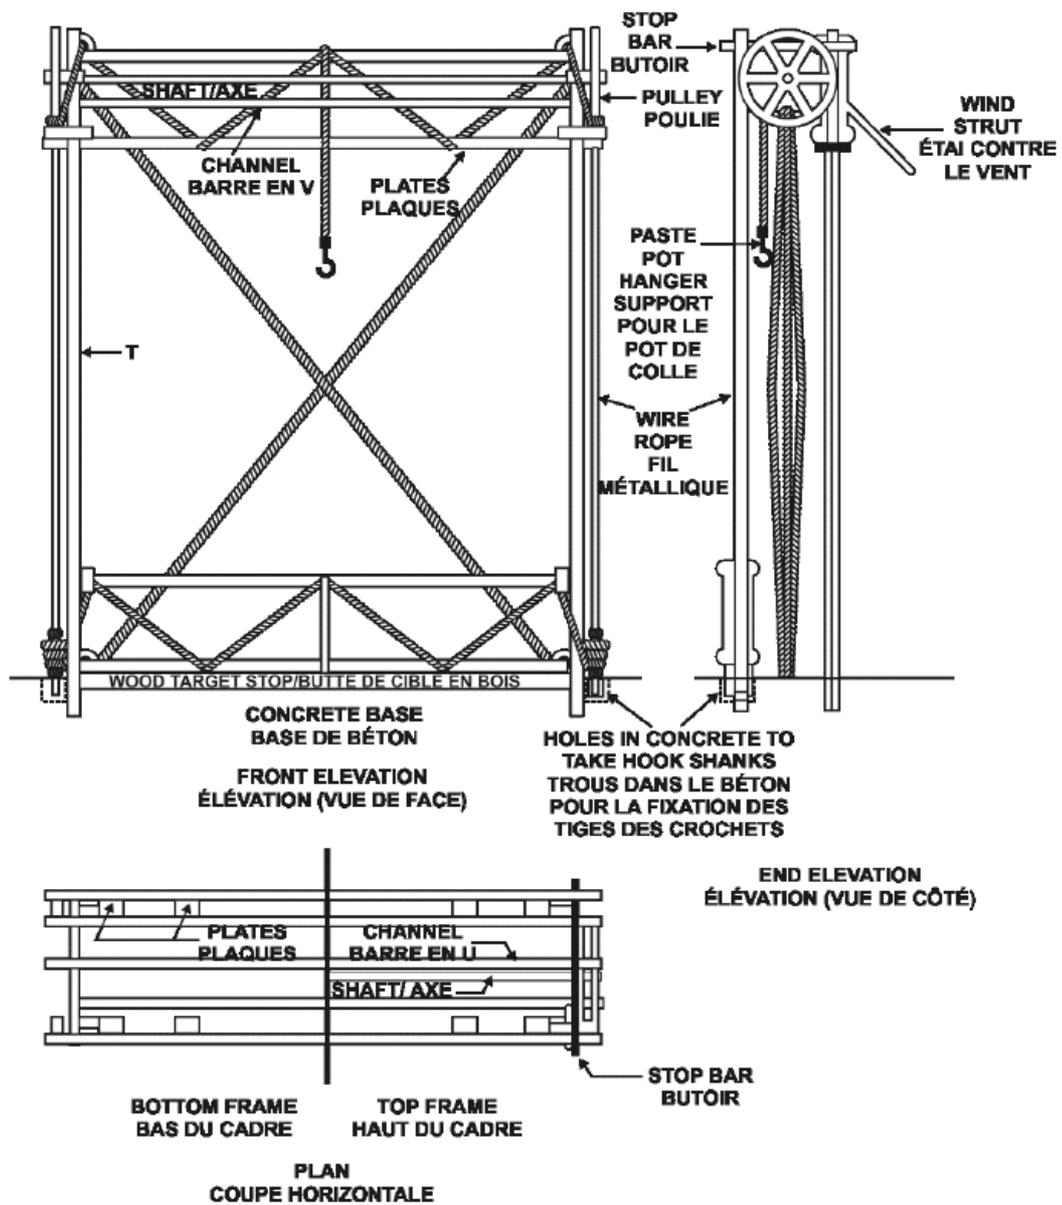
Figure 2 - A plan of the Hythe pattern target frame, taken from a Canadian bilingual manual (Canadian National Defence, 'Range Construction and Maintenance, B-GL-381-002/TS-000, dated 2009)

established in Kent in 1853. One source describes the frames as originally being built 'of malleable iron ... normally supplied by McQueens Ltd of Galashiels who hold the original drawings.'²⁵ Whatever their origin they were already a relatively old design by the time of World War II.
